## A Comparative Study of the Geotechnical Properties of Subsoils Along Failed and Unfailed Pavement Sections of Parts of the Enugu-Makurdi Expressway, Southeastern Nigeria

### Abstract

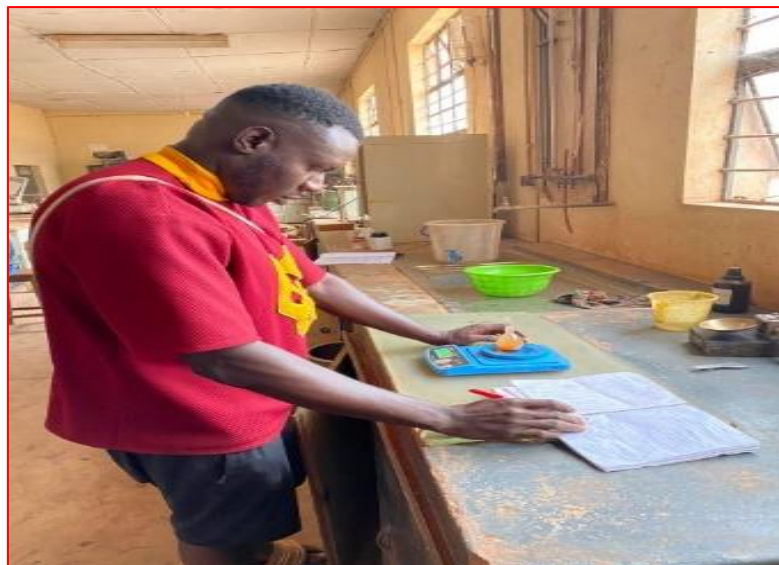
**Figure 2:** Laboratory procedures for determination of specific gravity

$V_1$  = Volume of the pycnometer bottle,  
 $W_2 - W_1$  = Weight of water,  $G_w$  = Specific gravity of water (typically 1 at standard conditions). This method ensures accurate determination of soil specific gravity, which is crucial for analyzing the soil's behavior under various environmental conditions. The procedure was performed in the laboratory using the pycnometer as shown in Figure 2.

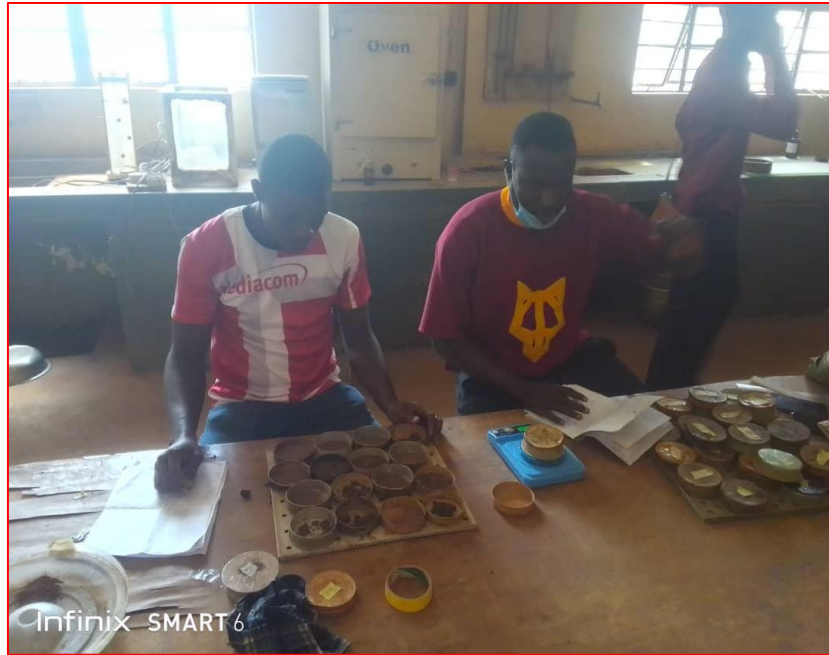
**Figure 4:** Showing lab procedures of moisture content

As shown in Figure 4, the method employed for determining the natural water content of the sample is outlined in the American Association of State Highway and Transportation Officials (AASHTO) A-2-4. The weight of the wet soil is measured using different cans on a weighing balance. Then, the soil is oven-dried for 24 hours, after which the weight of the dried soil is recorded (see Figure 4). The weight of the empty cans is also measured with the weighing balance.

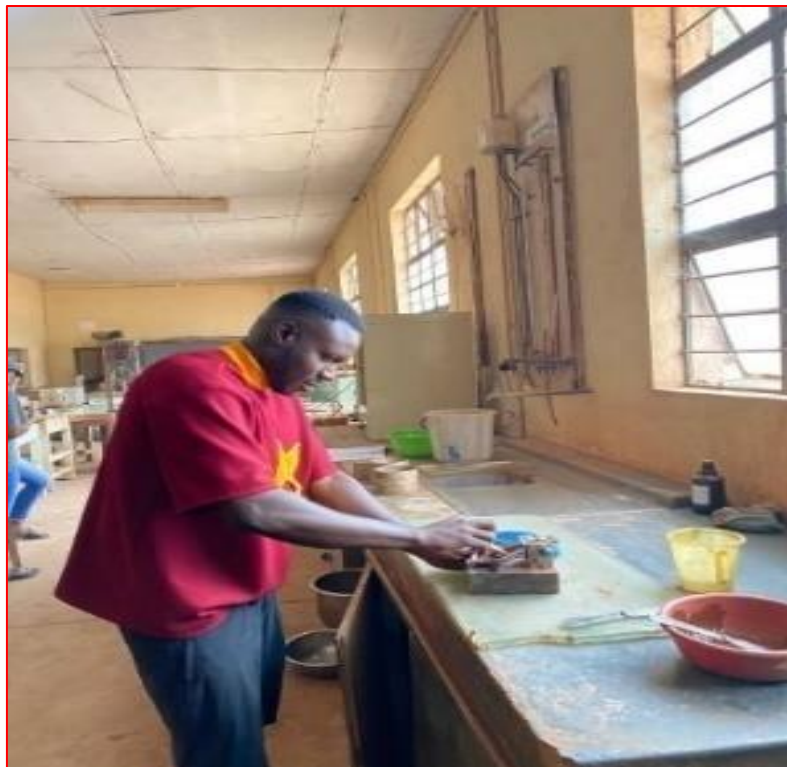
**Figure 5:** Showing lab procedures of liquid limit

this paste is placed into the cup of Casagrande's apparatus and leveled so that the surface is parallel to the base. The Casagrande grooving tool is then used to cut a standard groove through the center of the soil. Next, the handle of the Casagrande apparatus is cranked at a standard rate of two revolutions per second. The number of blows required to close the groove over a distance of 13 mm (or ½ inch) is recorded. This process is repeated several times with different moisture contents until the number of blows required to close the groove consistently falls between 15 and 35. A small sample of soil is taken from the center of the closed groove for moisture content determination. This moisture content, corresponding to 25 blows, is defined as the liquid limit

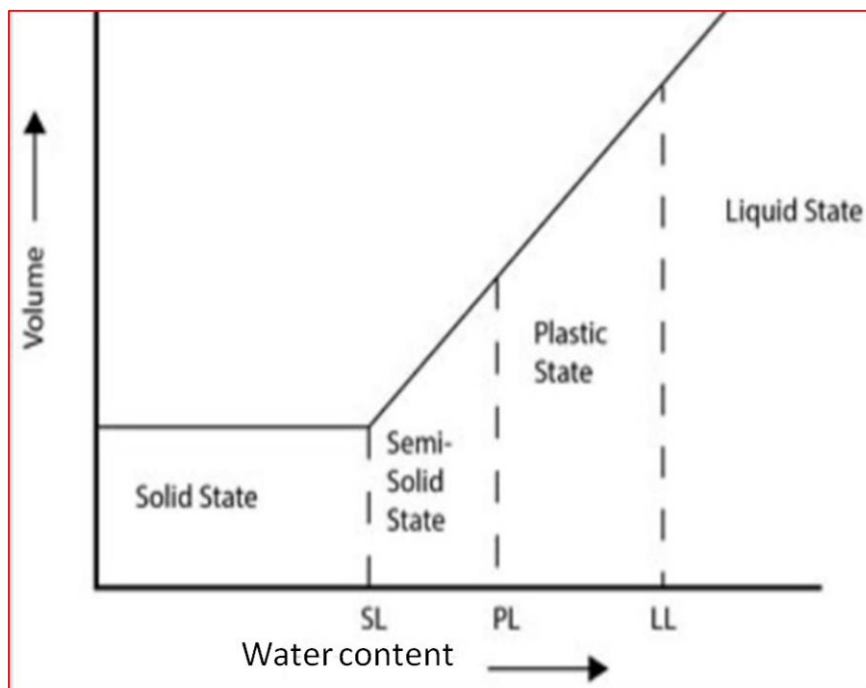
**Figure 6:** Showing stages of liquidity index of a soil (Atterbege, 1991)

Where  $w$  is the natural water content of the soil. If  $LI > 1$ : The soil is in a liquid state (very soft and flowable). For  $LI = 1$ , the soil is at its liquid limit. If  $LI$  between 0 and 1, the soil is in a plastic state (can deform without breaking) and if  $LI < 0$ : The soil is in a semi-solid or solid state (more stable, less deformable). In foundation engineering, the LI helps in understanding the workability and stability of soils, especially clays, under varying moisture conditions. It is useful in evaluating the risk of settlement or bearing capacity issues in soft or saturated soils. A cohesive soil can exist in any of the states called, semi-solid, plastic and liquid state, depending on the moisture content of the soil. The boundary between the liquid and semi-solid state is known as shrinkage limit, depicted as SL. According to Atterberg (1931), If the LI or a soil is greater than zero but less than or equal to one, the soil is in its liquid limit state. But if the liquidity index is equal to zero, then the soil is in the plastic state. The LI of a soil is illustrated in Figure 6. Liquidity index of a soil, was calculated using the formula in Equation 13.

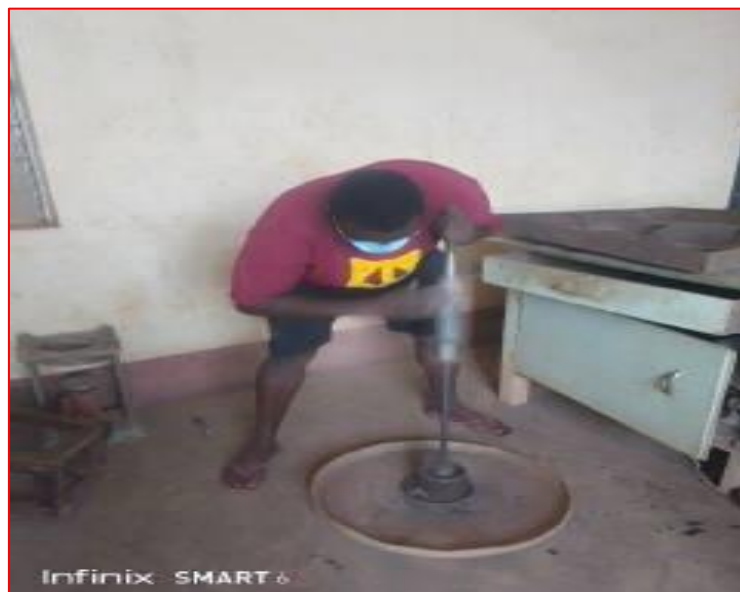
**Figure 7:** Showing lab procedure of compaction test

The apparatus used in the Proctor compaction test includes a Proctor mold or compaction mold, a detachable base plate, a removable collar, a drying oven, a graduated jar, a large mixing pan, a trimming knife, a weighing balance, and a 4.5 kg hammer or rammer. Approximately 3 kg of soil is typically used for each test. The dry density of the soil is related to its bulk density, maximum dry density (MDD), and optimal moisture content (OMC), as expressed mathematically in Equation 14.

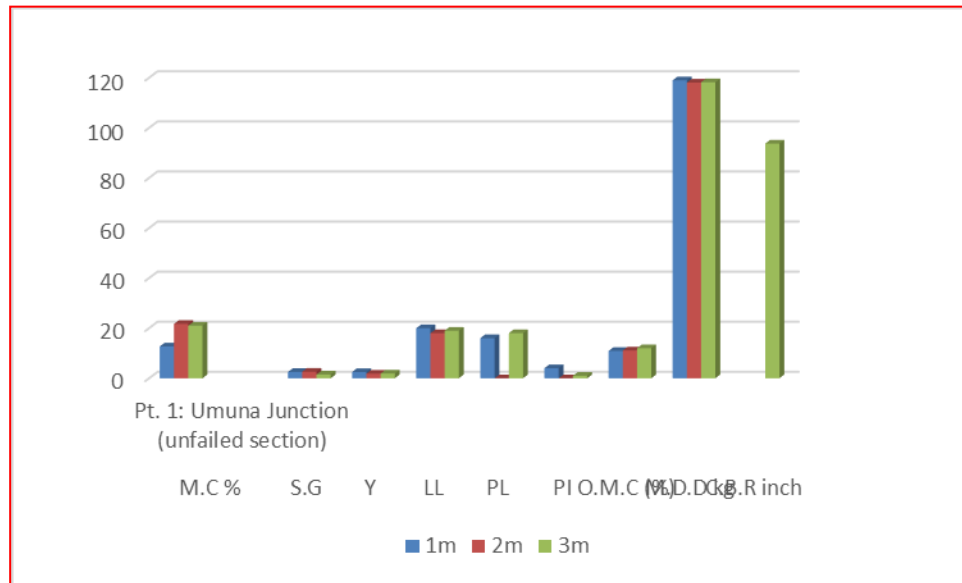
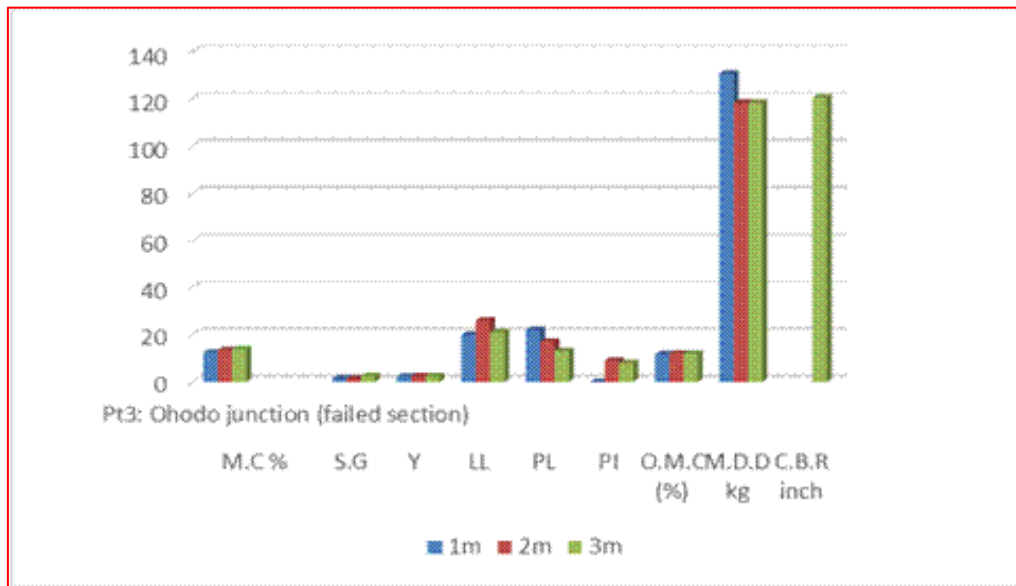
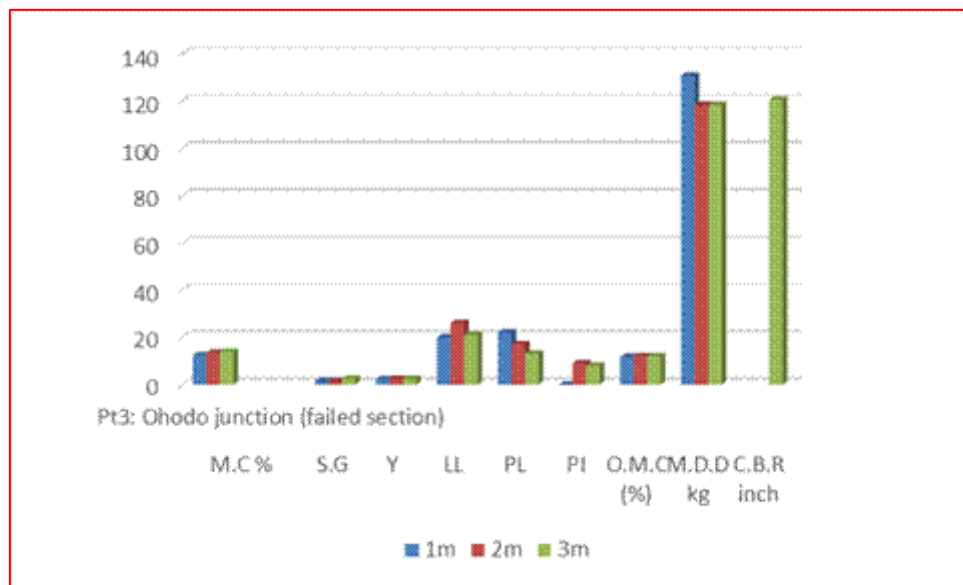
1m (12.7%). At Point 2, the highest MC was found at 1m, while values at 2m and 3m were equal. At Point 3, the 3m depth had the highest MC, followed by 2m, with the lowest value again at 1m. The pictorial descriptions of the parametric displays are given in Figures 9 to 11.

**Figure 9:** Showing the variations of geotechnical parameters of Umuna junction

**Figure 10:** Showing the variations of geotechnical parameters of Ozalla junction

**Figure 11:** Showing the variations of geotechnical parameters of Ohodo junction

The geotechnical properties of subsoils along both failed and unfailed sections of the Enugu-Makurdi Expressway reveal interesting trends, especially when comparing compaction characteristics. Regarding the compaction test results, several observations were made across three different points at varying depths. At Point 1, the Optimum Moisture Content (OMC) at 3 meters was higher than at 1 meter and 2 meters, with the OMC at 1 meter being the lowest (see Figure 9 to 11). In contrast, at Point 2, the OMC at 1 meter was higher than at 2 meters and 3 meters, with 3 meters showing the lowest OMC. At Point 3, the OMC at 3 meters and 2 meters were equal, and both were higher than the OMC at 1 meter (see Figure 9 to 11).

2 meters and 3 meters, with the values at 2 meters and 3 meters being equal (see Figure 9 to 11). These compaction characteristics are summarized in Table 1. When comparing the failed and unfailed sections of the Enugu-Makurdi Expressway, the OMC for the failed section ranged from 11.9% to 13.7%, while for the unfailed section, it ranged from 10.9% to 12.0%. Similarly, the MDD for the failed section varied between 114.8 and 130.6 kg/m<sup>3</sup>, whereas the unfailed section ranged from 118.1 to 119.0 kg/m<sup>3</sup> (see Figure 9 to 11). The variations in MDD and OMC were influenced by factors such as soil type, organic matter content, particle size distribution, and compactive effort, which directly affect soil compaction. (O'Flaherty, 2001). The Compaction Test Graph of failed section of Enugu-Markudi expressway at Ohodo junction is represented in the Figure 14.
